## CASE SERIES

### A Conservative Approach for Restoration of Grossly Decayed Vital Posterior Teeth using Fiber Reinforced Composites-A Case Series

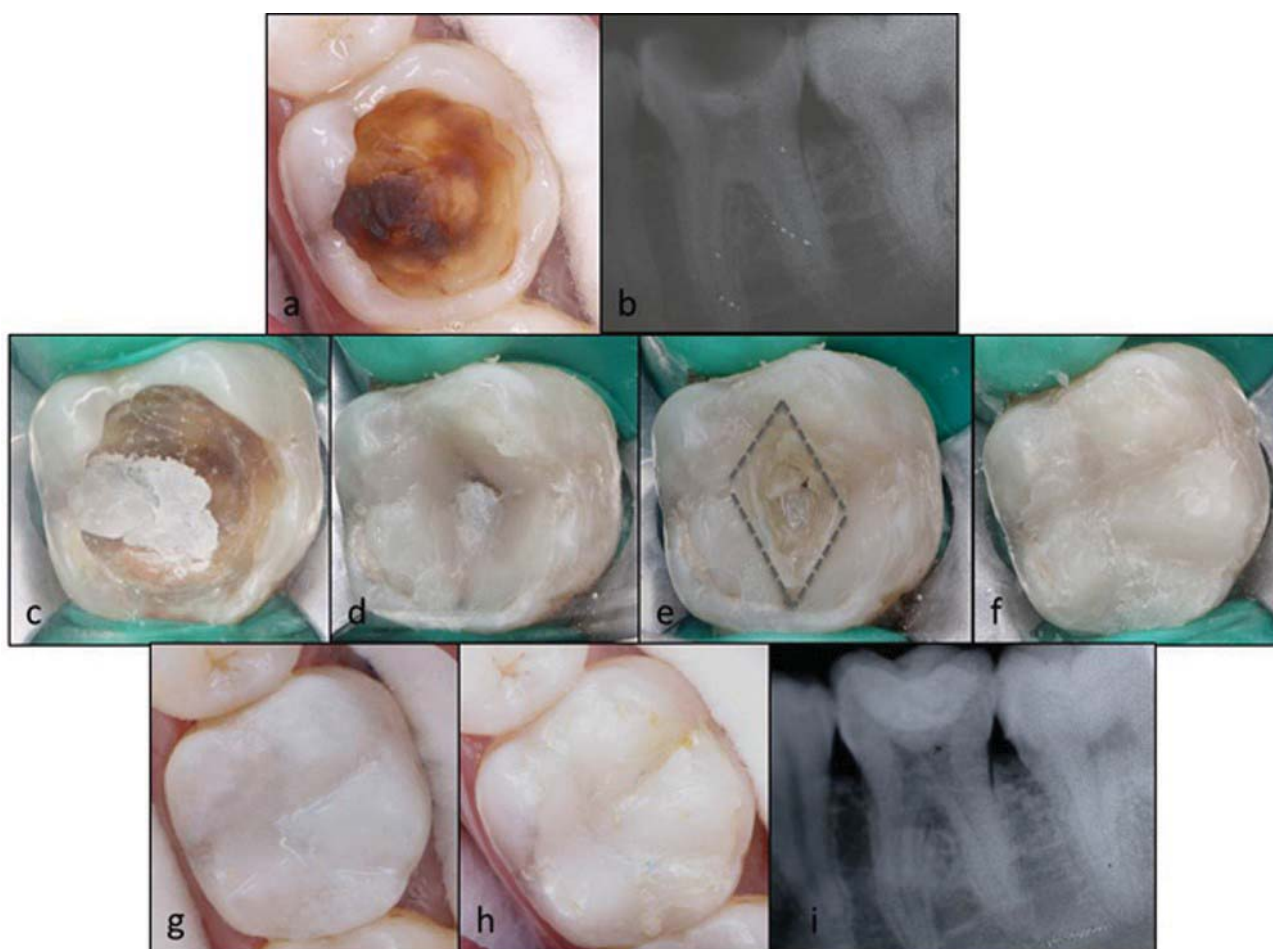
**Fig– 1: Case report 1**

any pain in the same tooth but slight discomfort was there. On visual examination, there was Class I caries on mandibular left molar with carious involvement of mesiobuccal, mesiolingual, distobuccal, distolingual cusps except marginal ridges.(Fig 1a) Probing test gave negative result. The periapical radiograph showed occlusal radiolucency in dentin with no periapical

changes (Fig 1b). The case was diagnosed as occlusal cavitated carious disfigurement with deep dentin involvement.

- a.** Preoperative occlusal view of left mandibular first molar
- b.** Preoperative radiograph of left mandibular first molar
- c.** Pulp protection with glass ionomer cement
- d.** Inclined cuspal planes created for lost cusps
- e.** Bonding of four pieces of Ribbond over the inclines
- f.** Restoring cuspal anatomy with composite restoration
- g.** Immediate post operative occlusal view after finishing and polishing
- h.** 9 months follow up
- i.** Post operative follow up radiograph

All the soft caries was excavated and GIC base was applied (Fig 1c). The first increment of composite (Filtek Z350, 3M ESPE; India) was placed on the pulpal floor to create the

inclined cuspal plane of all lost cusps. (Fig 1d) The thickness of the increment was variable so that at least 1.5mm of space was present from occlusal surface for the final increment. Over the created incline planes, four pieces of ribbon (Ribbon bondable reinforcement ribbon, US) of 2mm width of variable length, impregnated with bonding agent (Adper Single Bond, 3M ESPE; India), were placed on all the four cusps (mesiobuccal, distobuccal, mesiolingual and distolingual) (Fig 1e). The final increment of composite was done over ribbon (Fig 1f) Finishing and polishing of the restoration was done after checking for the high points (Fig 1g). Short term follow up was done for the case (1h, 1i).

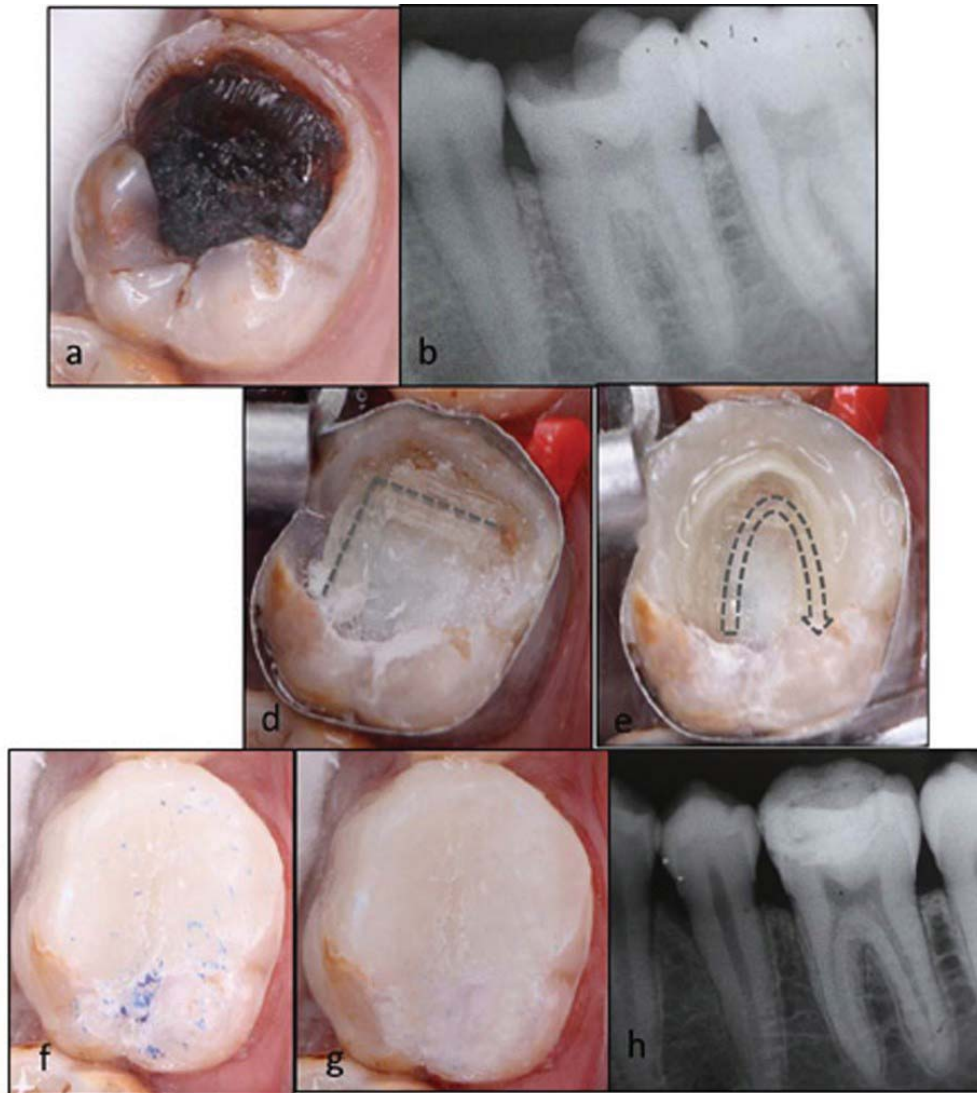
**Fig– 2: Case report 2**

21 years old male patient reported with the chief complaint of decay in his right lower back tooth and wanted the filling of the same tooth. He complained of food lodgment in the same tooth but there was no pain with respect to the same tooth. On visual examination, mandibular right first molar showed Class I extensive caries involving mesiobuccal and mesiolingual cusps, (Fig 2a). Probing test showed a negative result. There was no periodontal attachment loss on any surface. The periapical radiograph showed mesioocclusal radiolucency extending deep into dentin with no evidence of pulpal involvement (Fig 2b). The case was diagnosed

as occlusal cavitated carious disfigurement with deep dentin involvement.

- a.** Preoperative occlusal view of right mandibular first molar
- b.** Preoperative radiograph of right mandibular first molar
- c.** Pulp protection with glass ionomer cement
- d.** Two Ribbond fibers in L- shaped manner over the floor of composite restoration
- e.** Placement of fiber along the circumferential composite build up for the lost structure
- f.** Restoring cuspal anatomy with composite restoration
- g.** 11 months follow up
- h.** Post operative follow up radiograph

Soft caries excavation was done using a spoon excavator and arrested caries, after confirmation with caries detector dye (Caries Detector, Kuraray America, Inc.) was sealed with GIC. A thin layer of composite material (Filtek Z350, 3M ESPE; India) was bonded to the floor of the cavity. Two ribbon fibers (2mm width) (Ribbon bondable reinforcement ribbon, US) impregnated with bonding agent (Adper Single Bond, 3M ESPE; India), were bonded on the floor of the cavity in an L-shape manner, one fiber in buccolingual orientation and second in mesiodistal (Fig 2d). Further composite build up was done along the circumference of the involved lesion. Then a single ribbon fiber was bonded extending from distobuccal cusp following mesiobuccal axial line angle to mesiolingual axial line angle of the tooth till mesiolingual groove, sparing mesiolingual cusp (Fig 2e). Further cusps build up and occlusal adjustment was done (Fig 2f). Eleven months follow up was done (2g, 2h).

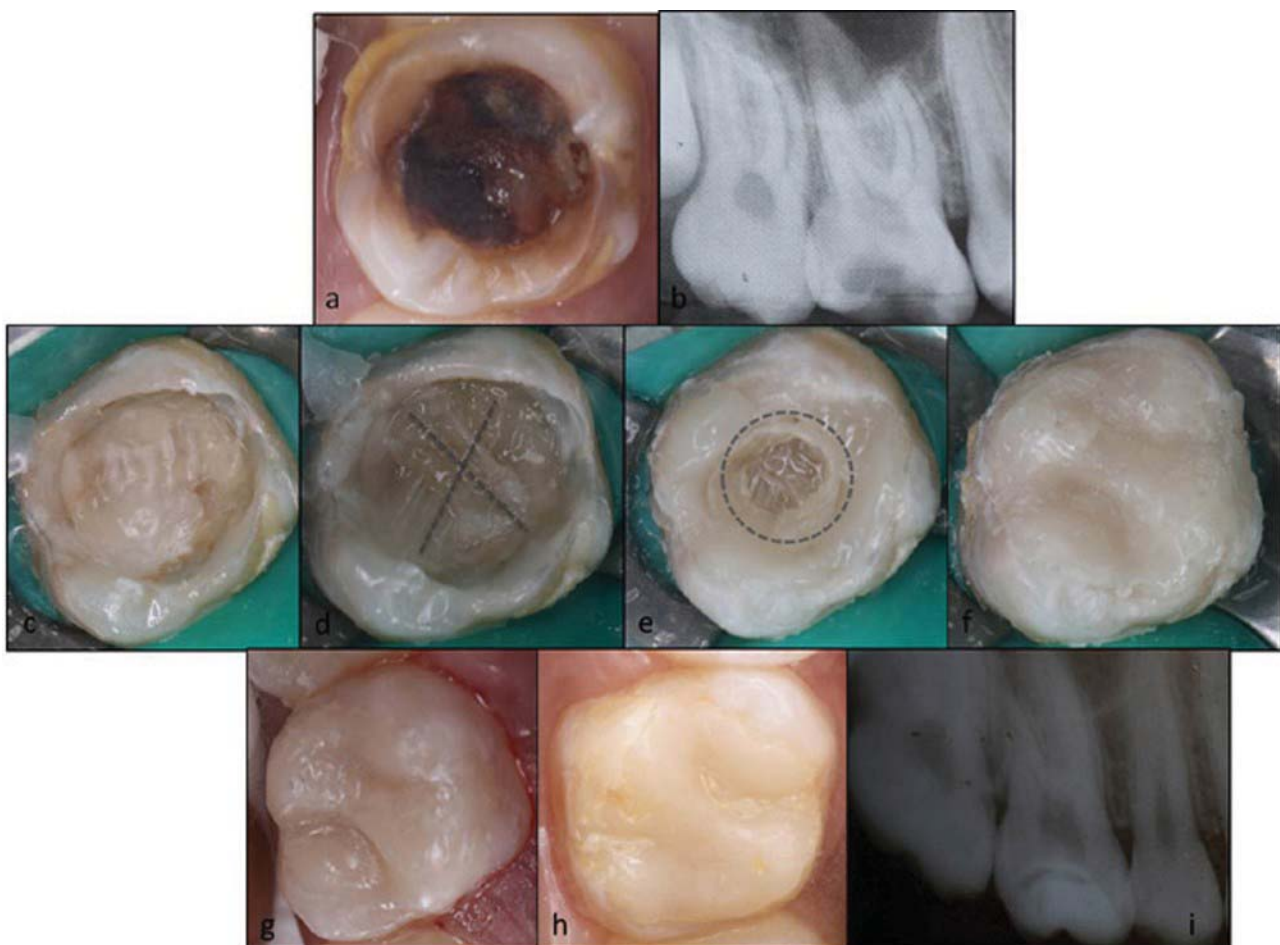
Fig– 3: Case report 3

was similar like Case1 with involvement of all four cusps and similar to case 2 with deep dentin involvement (Fig 3a). Periapical radiograph showed occlusal radiolucency extending in deep dentin without pulpal involvement. (Fig 3b)

- a.** Preoperative occlusal view of right maxillary first molar
- b.** Preoperative radiograph of right maxillary first molar
- c.** Pulp protection with glass ionomer cement
- d.** Two Ribbon fibers placed obliquely over the floor of composite restoration
- e.** Circumferential placement of Ribbon along the cuspal inclines
- f.** Restoring cuspal anatomy with composite restoration
- g.** Immediate post operative occlusal view
- h.** 10 months follow up
- i.** Post operative follow up radiograph

The treatment protocol involved was the combination of treatments done in case 1 and case 2A thin layer of composite material (Filtek Z350, 3M ESPE; India) was bonded to the floor of the cavity after complete excavation of caries and pulp protection using GIC(Fig 3c). Two Ribbond fibers (Ribbond

bondable reinforcement ribbon, US) of 2mm width of variable length, impregnated with bonding agent (Adper Single Bond, 3M ESPE; India) were placed obliquely on the floor of the cavity, one from mesiobuccal to distopalatal and another from distobuccal to mesiopalatal cusps, as shown in the fig (Fig 3d). Composite build up was done along the four cuspal inclines. Then a single ribbon fiber was bonded circumferentially along this

composite buildup.(Fig 3e) Further cusps build up was done using composite restoration (Fig 3f). Occlusal correction as well as finishing and polishing of the restoration were done (Fig 3g). A follow up of 10 months was done for the same (Fig 1h, 1i).

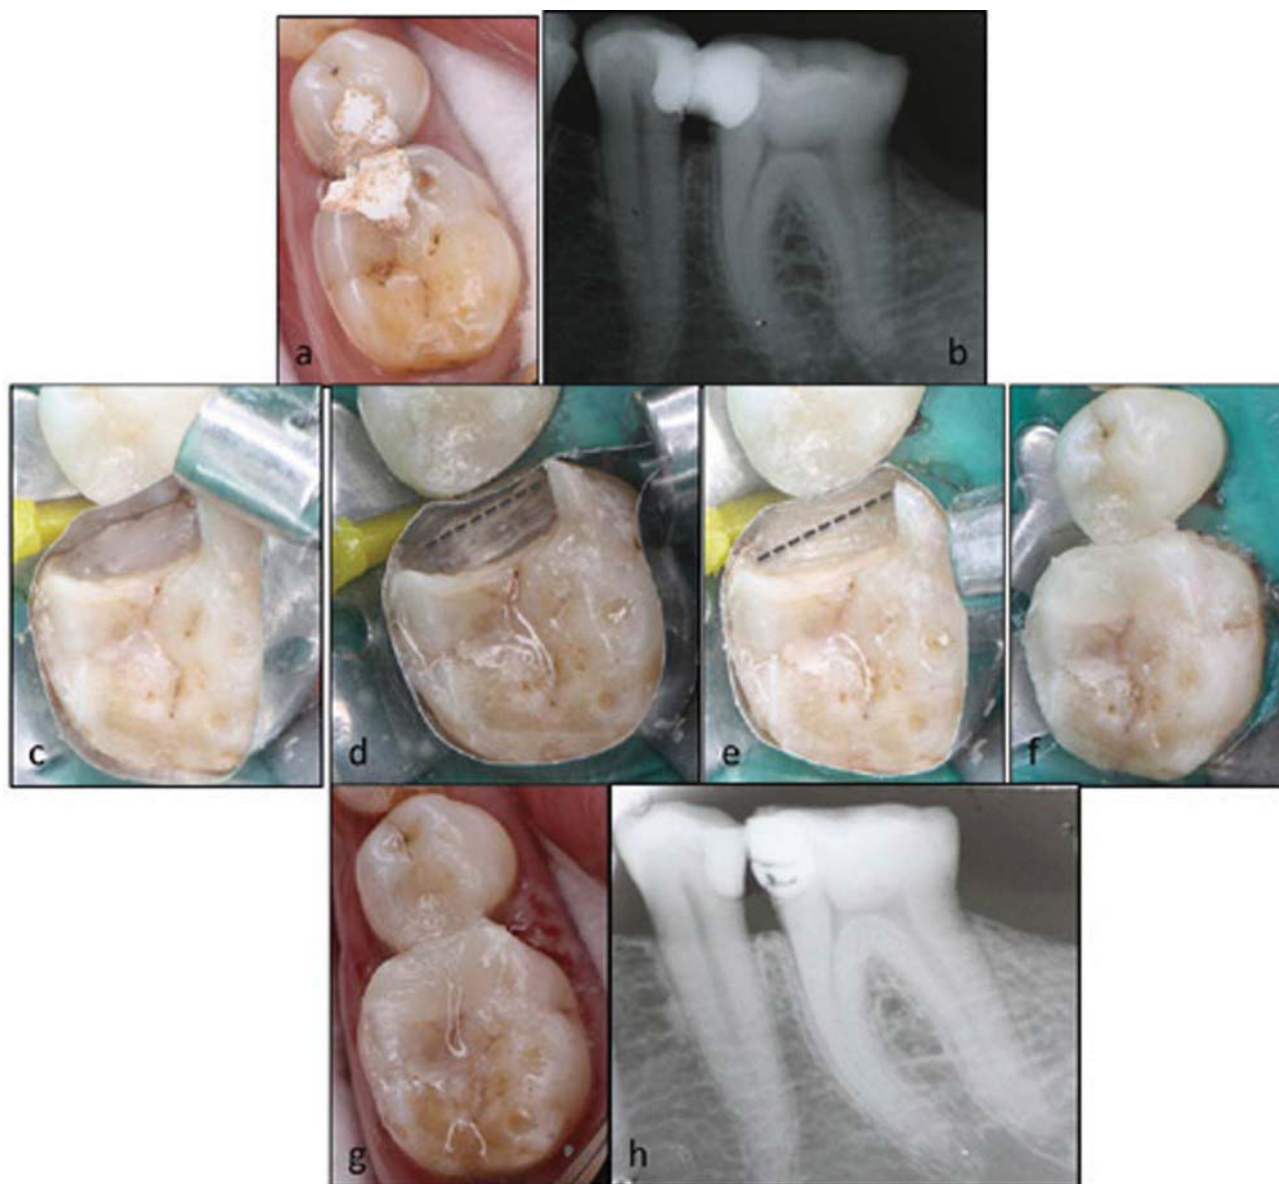
**Fig– 4: Case report 4**

teeth were filled with white colored temporary restoration (Fig 4a) Teeth were non tender on percussion with sound periodontal health. On removal of temporary restoration (Fig 4b), there was class II mesiobuccal caries in left lower first molar involving mesiolingual axial

- a.** Preoperative occlusal view of left mandibular first molar
- b.** Preoperative radiograph of left mandibular first molar
- c.** First 1mm increment of composite material over the gingival seat
- d.** First Ribbond fiber in buccolingual direction over the gingival seat
- e.** Second Ribbond fiber in buccolingual direction over the gingival seat after second increment of composite material
- f.** Restoration using composite material
- g.** Post operative occlusal view
- h.** Post operative radiograph

line angle of the tooth and Class II distobuccal caries in left second premolar involving the contact area.

After soft caries excavation, pulp protection was done using GIC on the axial walls of both the teeth. Premolar tooth was restored with composite. Depth of the axial wall of molar was around 5mm as estimated using a

calibrated periodontal probe. Approximately 1 mm increment of composite (Filtek Z350, 3M ESPE; India) was done on the gingival seat (Fig 4c), then a ribbon (Ribbond bondable reinforcement ribbon, US) of 2mm width impregnated with bonding agent (Adper Single Bond, 3M ESPE; India), was bonded from buccal to lingual side on the floor (Fig 4d). Second increment of composite was placed over ribbon and light cured. Second fiber

piece of 2mm width ribbon impregnated with bonding agent was placed (Fig 4e) and the cavity was restored with composite (Fig 4f). Occlusal rehabilitation, finishing and polishing was done (Fig 4g) and a radiograph was taken (Fig 4h).

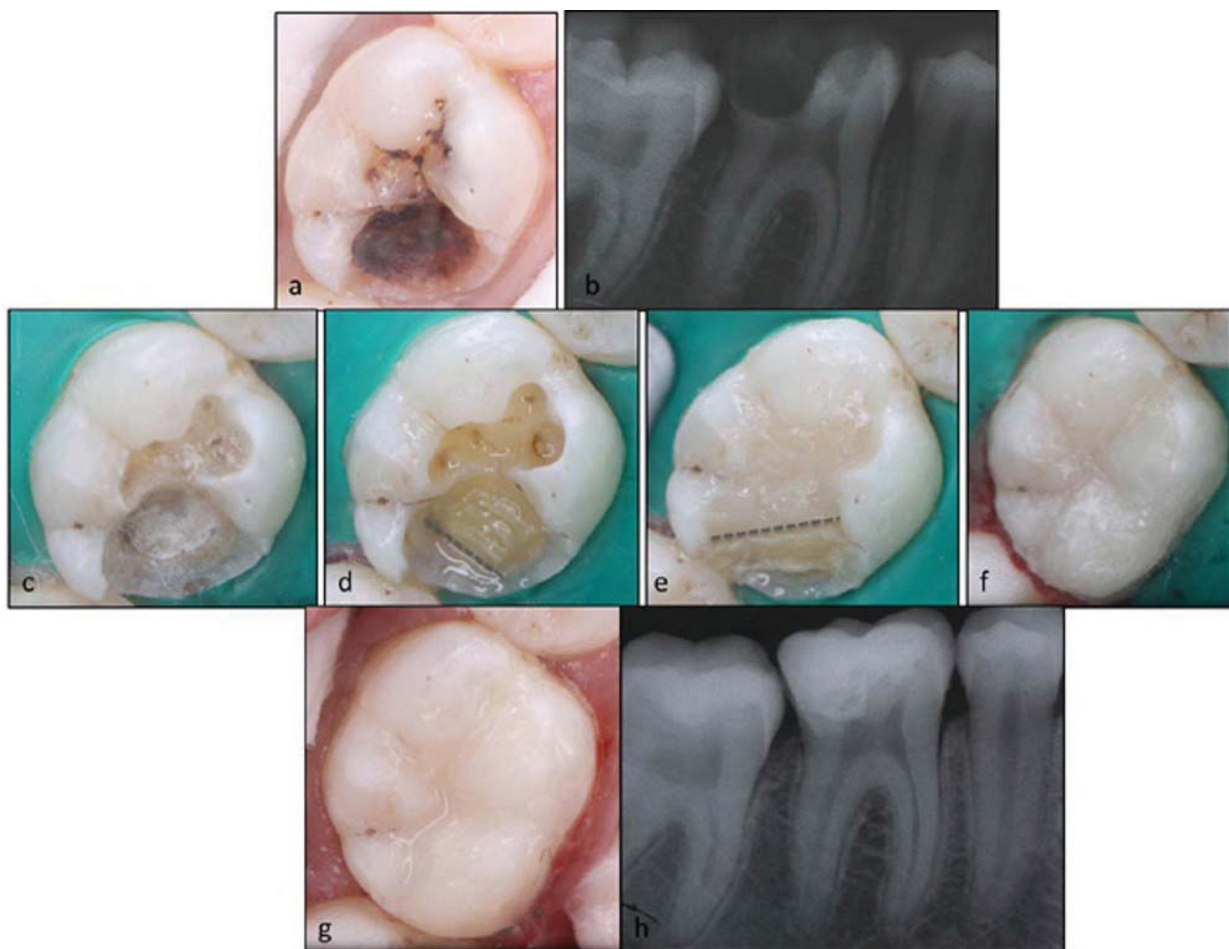
Fig– 5: Case report 5

- a.** Preoperative occlusal view of right mandibular first molar
- b.** Preoperative radiograph of right mandibular first molar
- c.** Pulp protection using glass ionomer restoration
- d.** First Ribbond fiber in buccolingual direction over the gingival seat
- e.** Second fiber in buccolingual direction over second composite increment at 45 degree incline extending from buccal proximal wall to the lingual proximal wall, covering the axial wall
- f.** Restoration using composite material
- g.** Post operative occlusal view

A female patient aged 22 years reported with a chief complaint of decay in her lower right back tooth without any pain. On visual examination, right mandibular first molar had class II caries involving distolingual cusp, extending beyond the lingual developmental groove (Fig 5a). Radiographically, disto-occlusal radiolucency very close to pulp chamber space was observed (Fig 5b). The case was diagnosed as reversible pulpitis.

Active carious lesion was excavated using a bur and spoon excavator. There was no exposure of pulp on thorough evaluation. Pulp protection was done using GIC (Fig 5c). First increment of composite (Filtek Z350, 3M ESPE; India) was placed over GIC in thin layer corresponding to the lingual developmental groove. The height of composite increment was limited to the inner third of dentin. Composite increment was light cured and ribbon fiber (Ribbon bondable reinforcement ribbon, US) of 2mm width impregnated with bonding agent (Adper

Single Bond, 3M ESPE; India) was placed over the composite increment (Fig 5d). Second increment of composite was layered over ribbon. The composite was extended from buccal proximal wall to the lingual proximal wall, covering the axial wall. Composite build up was done at 45 degree incline which covered most the cavity preparation leaving 1mm cavity from the cavosurface margin. Following light curing, second piece of ribbon of 2mm width, impregnated with bonding agent, extending from the buccal to lingual proximal wall was placed (Fig 5e). The remaining cavity was filled with last increment of composite and light cured (Fig 5f). Finishing and polishing of the restoration was done and a post operative radiograph was taken.(Fig 5g).

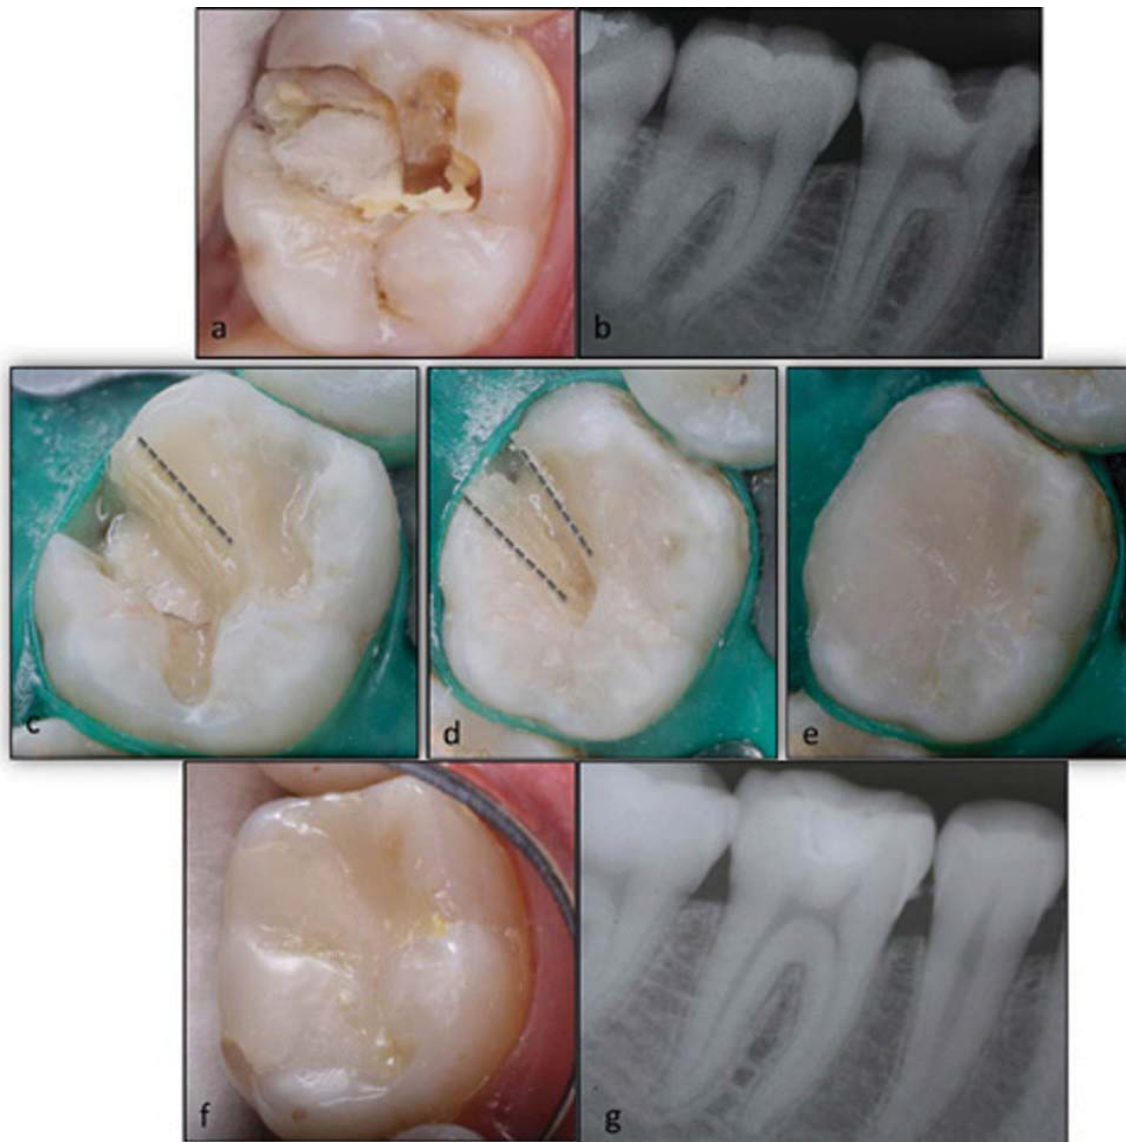
Fig- 6: Case report 6

A male patient reported with the complaint of decay in his lower right back tooth. Left mandibular first molar had Class I caries extending along the buccal developmental groove with partial loss of mesiobuccal and distobuccal cusps. (Fig 6a). The periapical radiograph showed occlusal radiolucency in inner third of dentin (Fig 6b).

- a.** Preoperative occlusal view of left mandibular first molar
- b.** Preoperative radiograph of left mandibular first molar
- c.** First fiber along the cuspal incline build up with composite for the lost mesiobuccal cusp
- d.** Second fiber along the cuspal incline build up with composite for the lost distobuccal cusp
- e.** Final restoration using composite material
- f.** Post operative occlusal view of 8 months follow up
- g.** Post operative follow up radiograph

Active carious lesion was excavated using a bur and spoon excavator. The cavity was protected with glass ionomer cement. Composite (Filtek Z350, 3M ESPE) build up

was done on mesiobuccal and distobuccal wall to create incline plane (Fig 6c). On each incline, 2mm width of ribbon fibers (Ribbond bondable reinforcement ribbon, US) impregnated with bonding agent (Adper Single Bond, 3M ESPE) were placed extending from the floor of the cavity to the 1.5 mm below the cavosurface margin (Fig

6d). Remaining cavity was restored with composite restoration. Finishing and polishing was done (Fig 6e). A short term follow up of around 8 months was done (Fig 6f, 6g) which revealed sound restoration other than little surface discoloration.
